Norfolk Spill Response Informational Update Meeting

December 20, 2022 – 7:00 PM

December 2022	
Project No. 16640	Figure
Site Layout	
Client: Federated Insurance	
Greenwoods Road East (Route 44)	
Norfolk, Connecticut 06058	
2

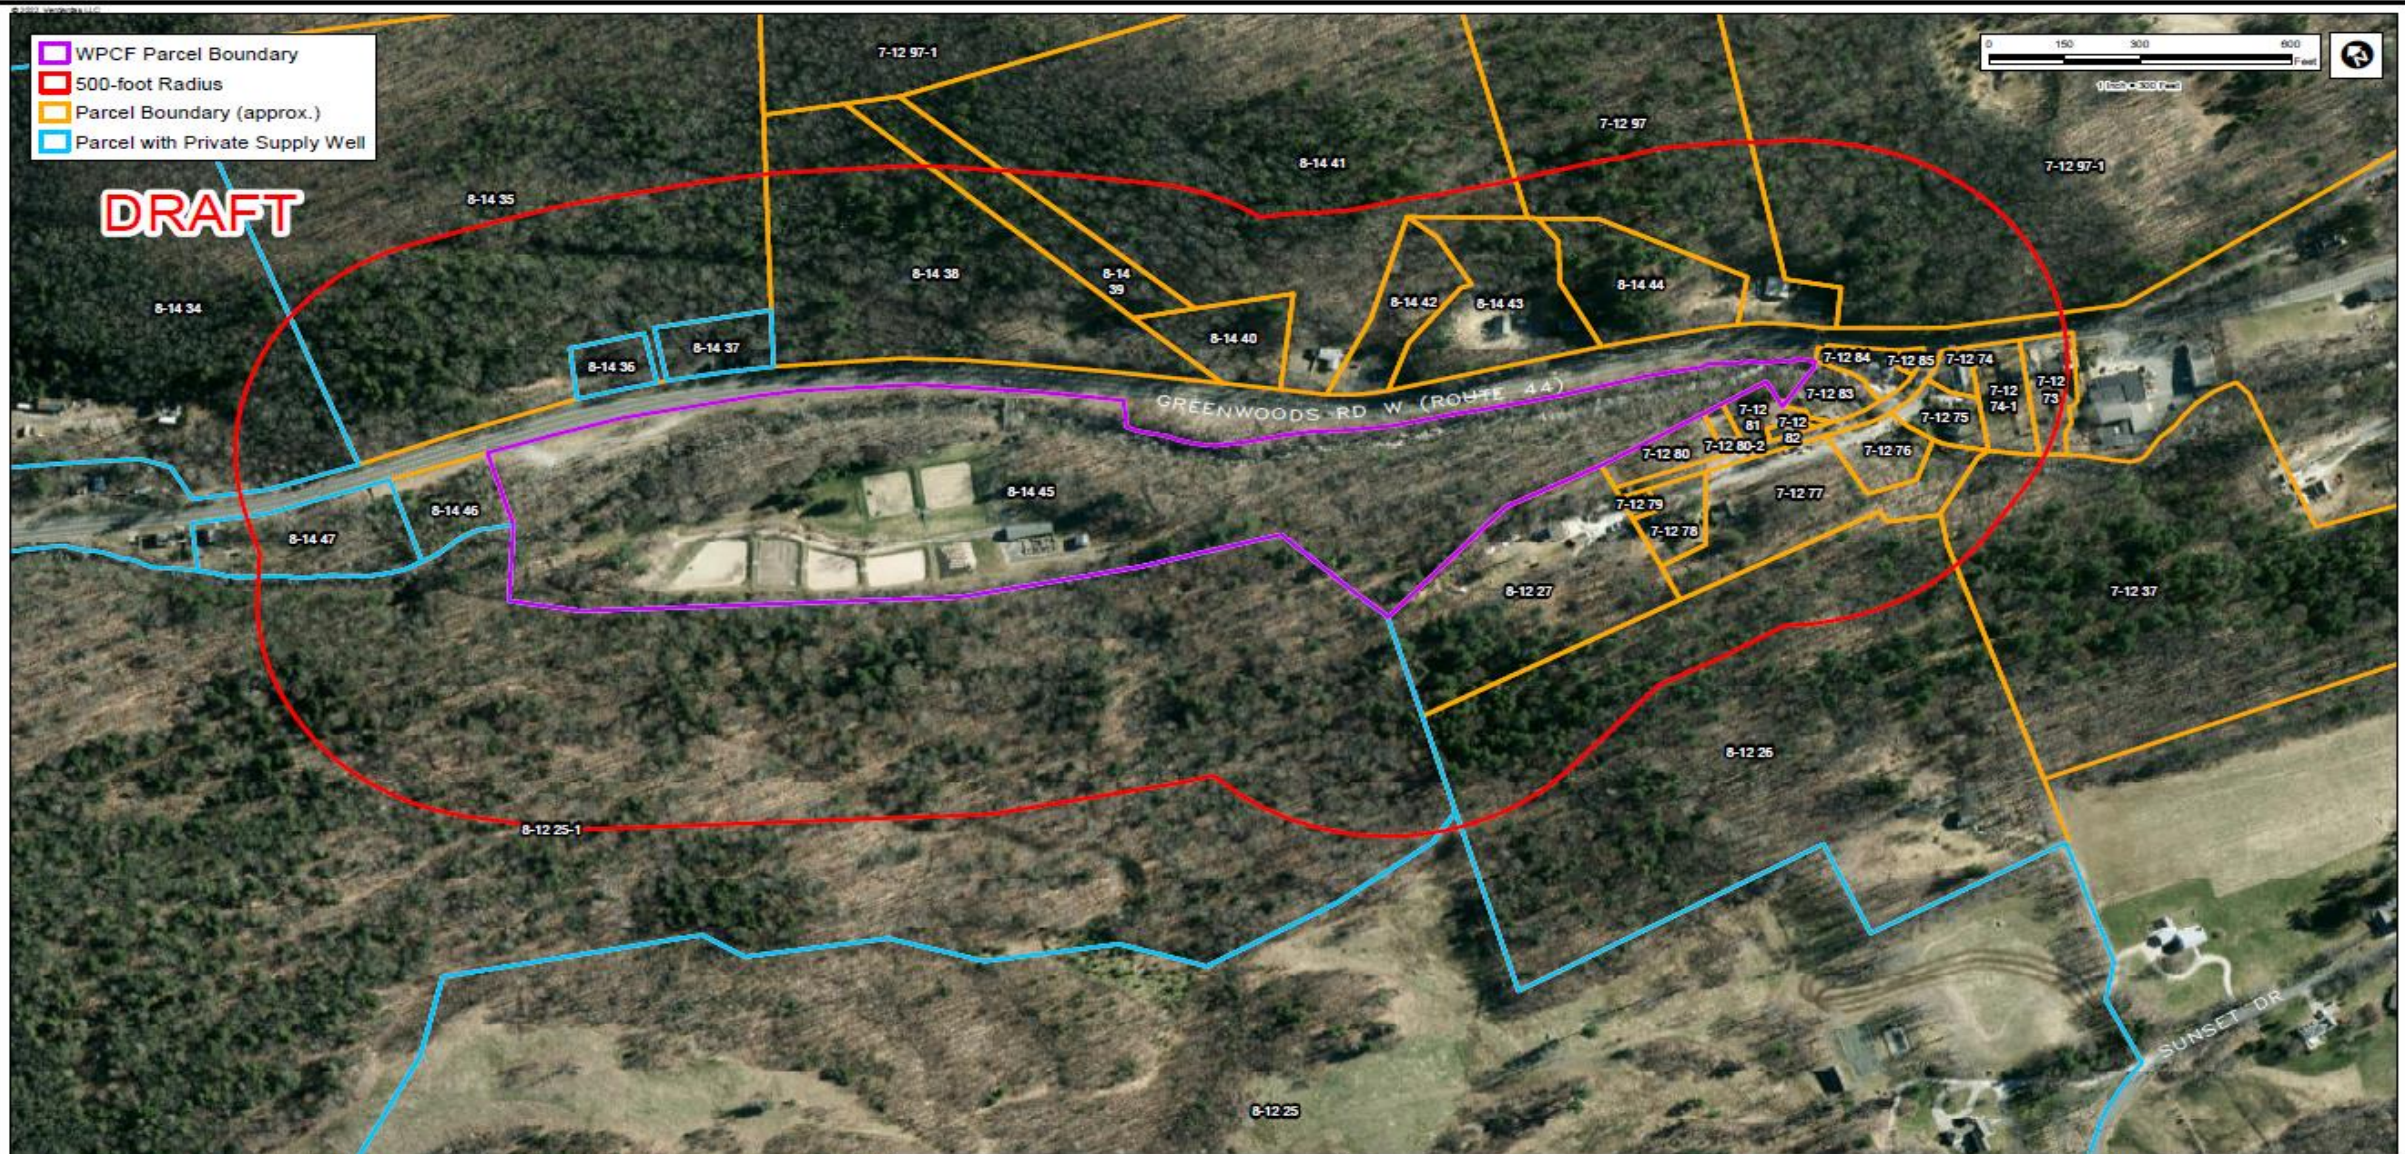
Figure
5

- WPCF Parcel Boundary
- 500-foot Radius
- Parcel Boundary (approx.)
- Parcel with Private Supply Well

December 2022
Project No. 16640
**Study Area Plan for
Water Pollution Control Facility**
Client: Federated Insurance
Greenwoods Road East (Route 44)
Norfolk, Connecticut 06058

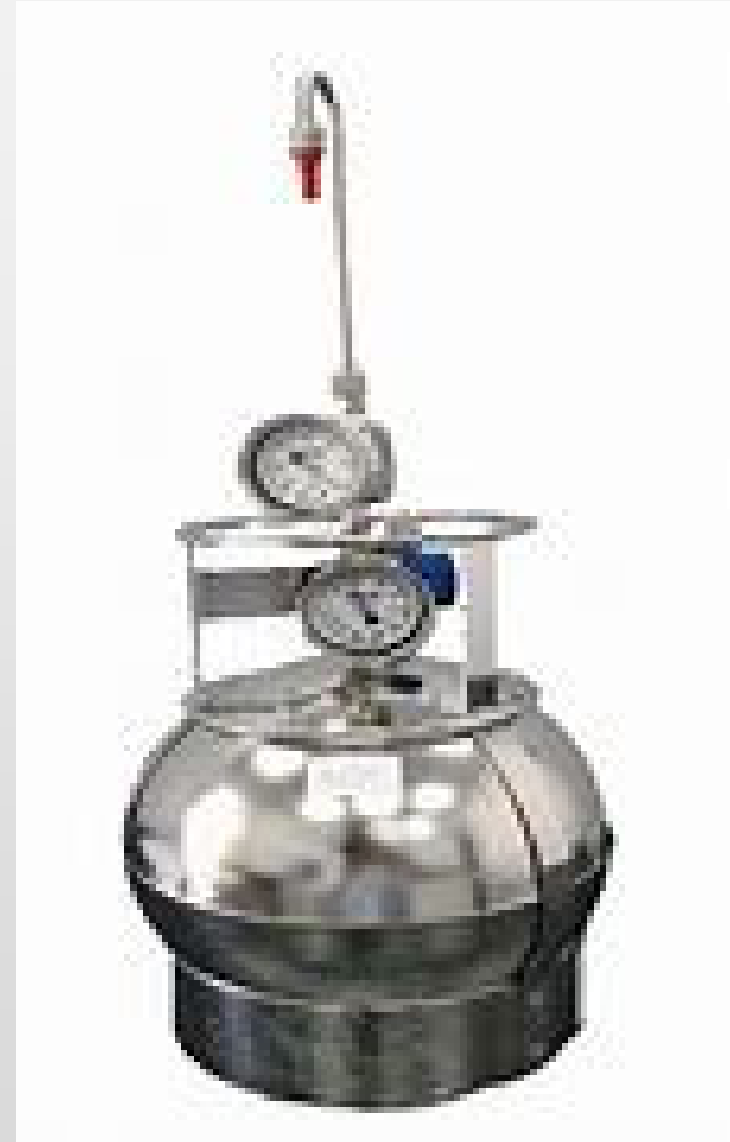
Sample Locations:

- *Basement*
- *First Floor*
- *Outdoors*

Sampling Apparatus:

- *Summa Canister*
- *6.0 Liter Capacity*
- *24 Hour Flow Regulator*

1. Baseline Air Sampling conducted in homes where gasoline odors are reported and/or homes determined by Verdantas to be in the pathway of spill
2. Sub-Slab Soil Vapor Sampling conducted in homes where gasoline may have seeped underneath the floor slab
3. Post-Remediation Air Sampling conducted in homes after remediation is completed on the house lot

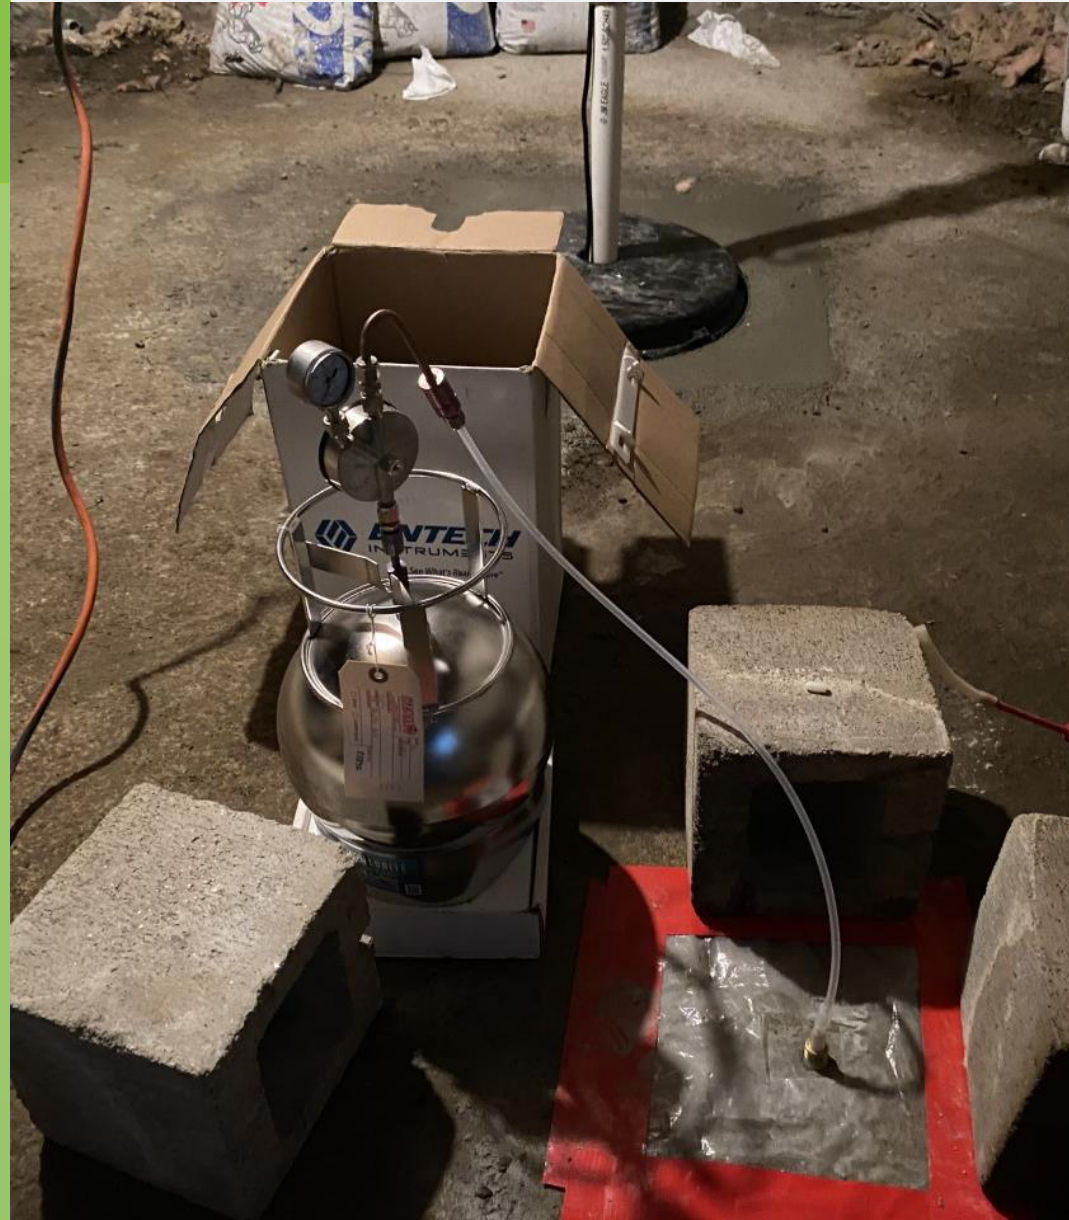
Sample Locations:

- *Basement of First Floor of homes with no basement*

Sampling Apparatus:

- *Summa Canister*
- *6.0 Liter Capacity*
- *4 Hour Flow Regulator*

Test results compared with Connecticut's 2021 Residential Volatilization Criteria

• Benzene	2,500 ug/m ³
❖ Toluene	160,000 ug/m ³
❖ Ethylbenzene	40,000 ug/m ³
❖ Xylenes	170,000 ug/m ³
